Fidalgo Marina Owners Association, Emergency Breakwater Repairs

Project Narrative

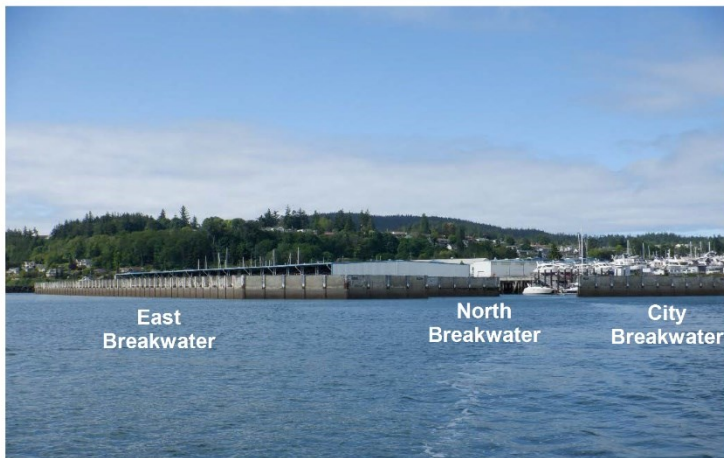
Figure 1 Fidalgo Marina Breakwaters

Fidalgo Marina is protected by three breakwaters. Two of the breakwaters, North and East breakwater, are owned by the Marina. The breakwaters are supported by steel batter piles that have sustained severe corrosive damage with some damage to the point of perforation (Figure 1).

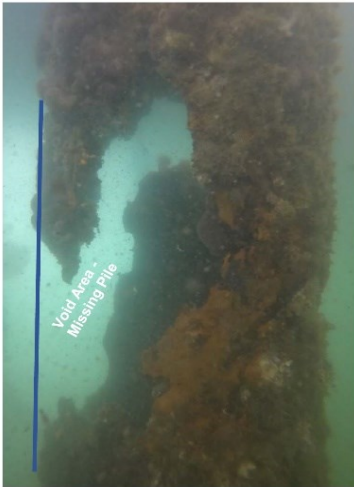
An inspection found 22 batter piles in the North Breakwater and East Breakwater to have sustained severe corrosion (Figure 2) (Echelon 2021). In addition, the remaining three of the North Breakwater batter piles have moderate damage requiring repair. Severe Damage was defined as protective coating or wrap damaged and loss of wall thickness exceeding 50 percent of nominal at any location. Moderate damage is defined as protective coating or wrap damaged and loss of thickness 15 to 30 percent of nominal; over 50 percent of perimeter or circumference affected by corrosion at any elevation or cross section; loss of thickness 15 to 30 percent of nominal.

Figure 2 Figure 2 Example of batter pile with corrosion to point of perforation (Echelon 2021).

These piles will be repaired using an internal pile repair system. Repair system will be CarboSleeve (sleeve) or CarboShield (also referred to as a temporary jacket or formwork herein) or approved equivalent. The temporary jackets or equivalent will be applied to the perforated portions of the pile to prevent grout from entering marine waters (Figure 3). Temporary formwork will be applied to the perforated portions of the pile to prevent grout from entering marine waters. Temporary formwork, to be provided by the contractor, could be fabricated from steel/timber or other acceptable materials. The sleeves will be inserted into the existing batter piles and grout pumped into the sleeve to

reinforce and strengthen the batter pile (Figure 4). Work will be performed from a barge; utilizing divers as required.

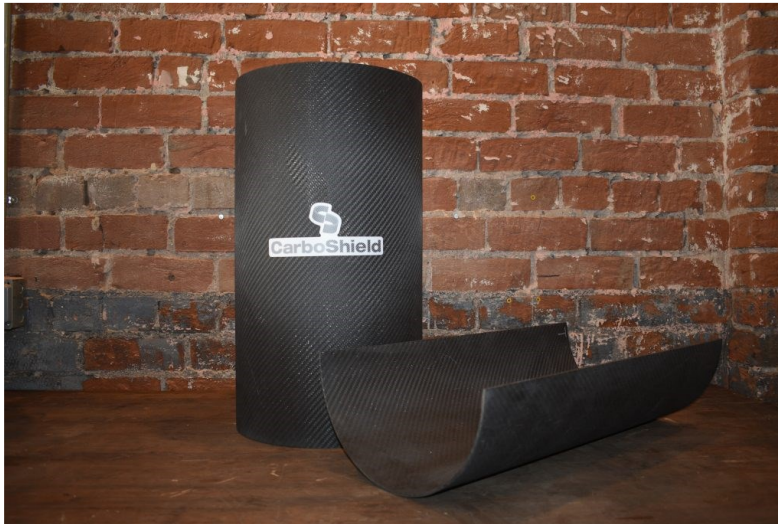
Figure 3 CarboShield™ (jacket or equivalent to be applied to perforations prior to grout injection).

1. Install temporary formwork at locations of pile perforations.
2. Cut access hole near the top of the pile.
3. Clean internal walls of pile by pressure blasting. Debris from cleaning will be contained and remain inside the pile cavity.
4. Install fiber reinforced sleeves inside the pile cavity through the access hole.
5. Epoxy grout is pumped into sleeves from the bottom of pile so it displaces the water upward as the grout fills the void. This keeps the grout from mixing with the water
6. Once grout has cured, temporary formwork is removed.
